INSPECTION REPORT

Inspection report No: INDIV-DXB/7761-01
Issue No: 01, Rev. 00
Report submission date: 06.07.2021
SGS Job No.: 50007761

A. Project:	Tender # HO20190248 Supply of Polycarbonate (PC), High Density Polyethylene (HDPE)/Glass Reinforced Plastics (GRP) for underground line plant furniture.	B. Supplier:	Smithline Reinforced Composite FZ-LLC. Jazeerah Al Hamrah Free Zone, Ras Al-Khaimah, U.A.E.
Project Ref. No.:	Tender # HO20190248	Details:	Visual Inspection, Witness of Dimensional Check and Load Test of the Manhole Chambers for Product Qualifications. (Qty-05 no's)
P.O. Ref No:	SMITH / 2626 / 21 May dated 23/05/2021.	Job No:

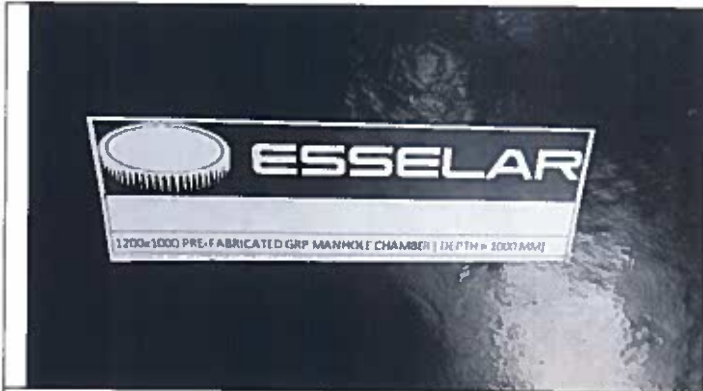
VERIFIED CHAMBER DIMENSIONS (1200 x 1000 MM)

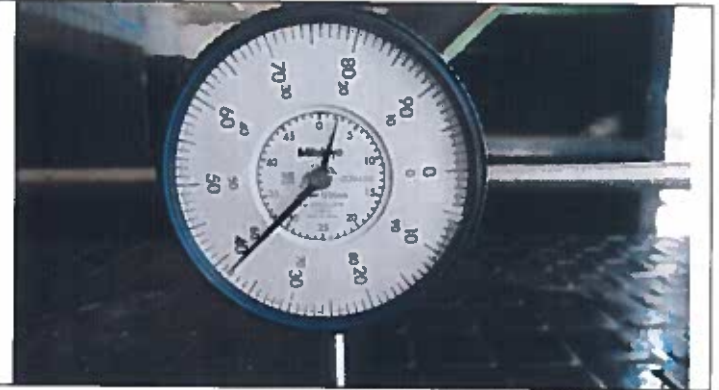
VERIFIED DEFLECTION INITIAL READING

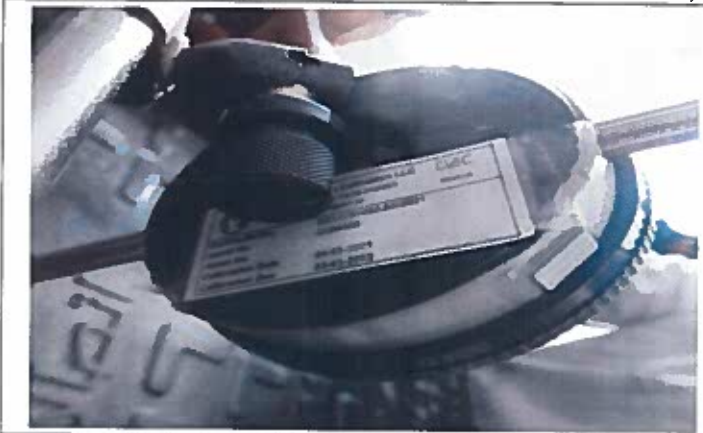
VERIFIED DEFLECTION GAUGE CALIBRATION STATUS

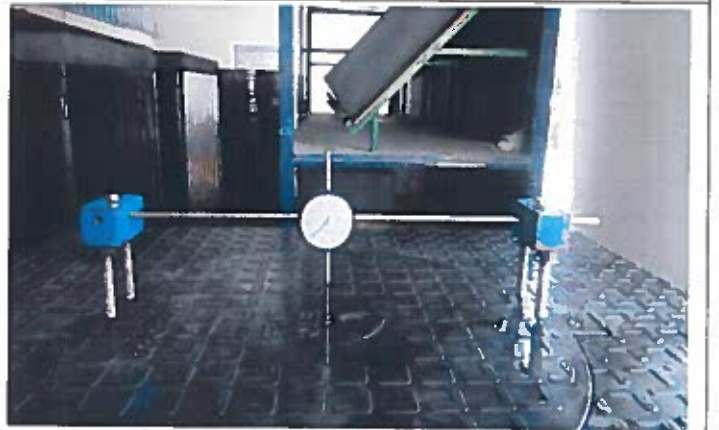
VERIFIED DEFLECTION INITIAL READING

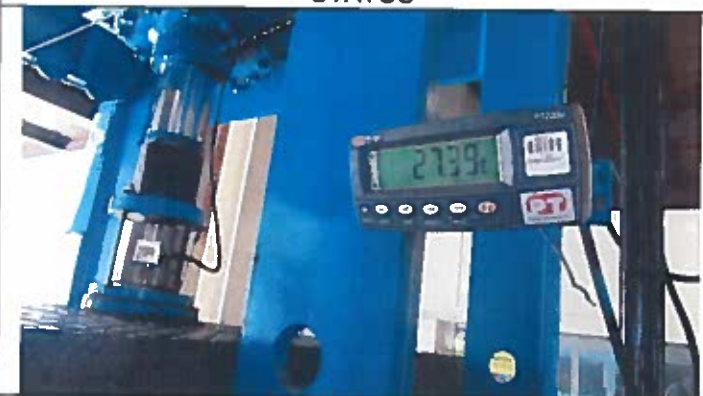
VERIFIED LOAD TEST FIRST READING
(1200 x 1000 MM)

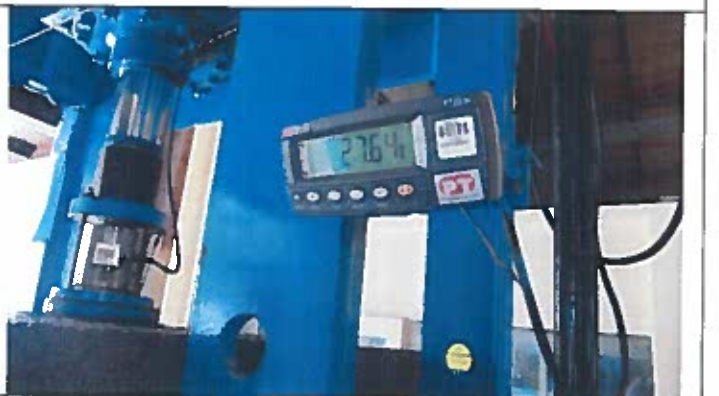
VERIFIED LOAD TEST SECOND READING
(1200 x 1000 MM)

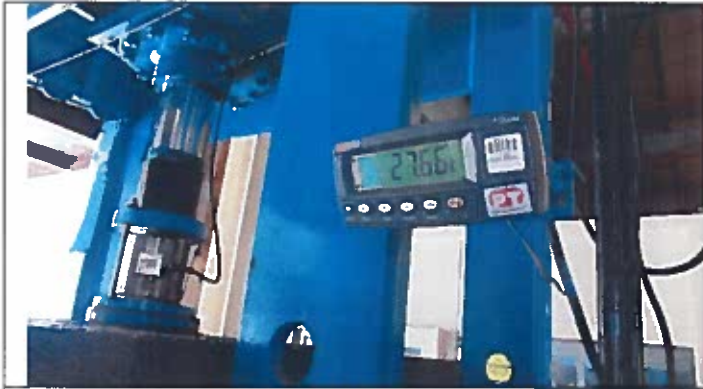
VERIFIED LOAD TEST THIRD READING
(1200 x 1000 MM)

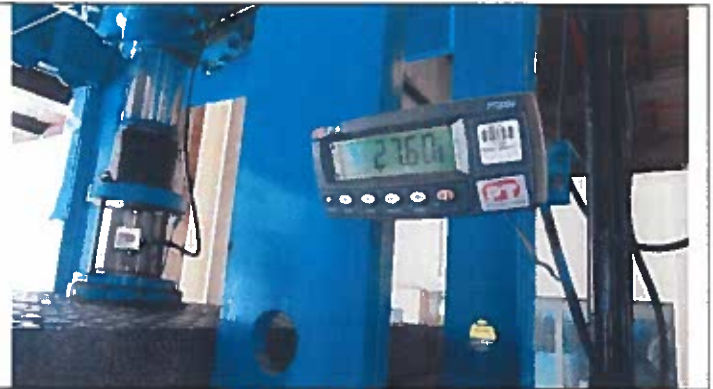
VERIFIED LOAD TEST FOURTH READING
(1200 x 1000 MM)

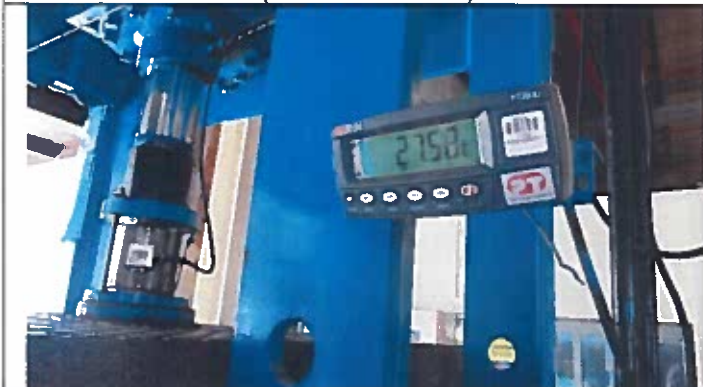
VERIFIED LOAD TEST FIFTH READING
(1200 x 1000 MM)

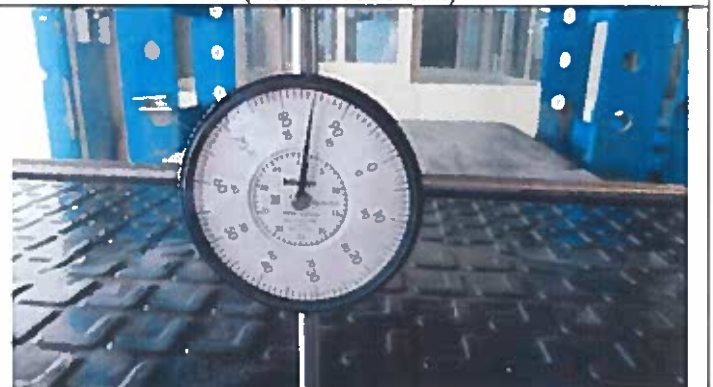
VERIFIED DEFLECTION FINAL READING

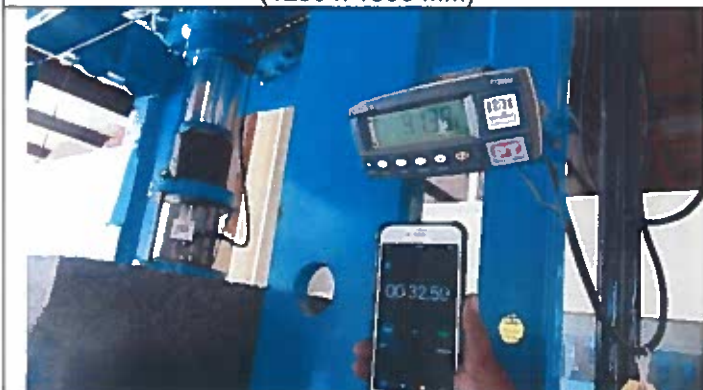
VERIFIED LOAD TEST READING (1200 x 1000 MM)

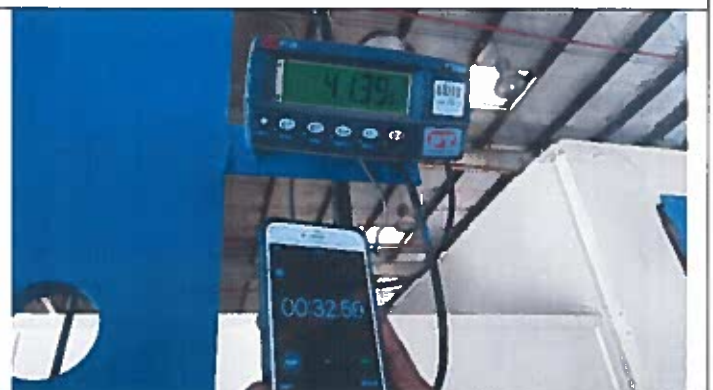
VERIFIED LOAD TEST READING (1200 x 1000 MM)

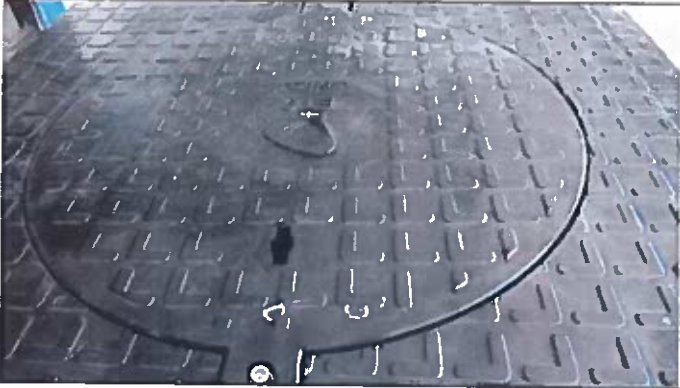
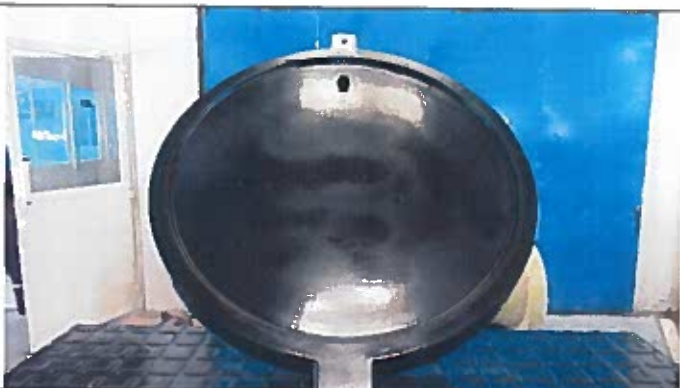
<p>VISUAL INSPECTION (1200 x 1000 MM)</p>	<p>VISUAL INSPECTION (1200 x 1000 MM)</p>

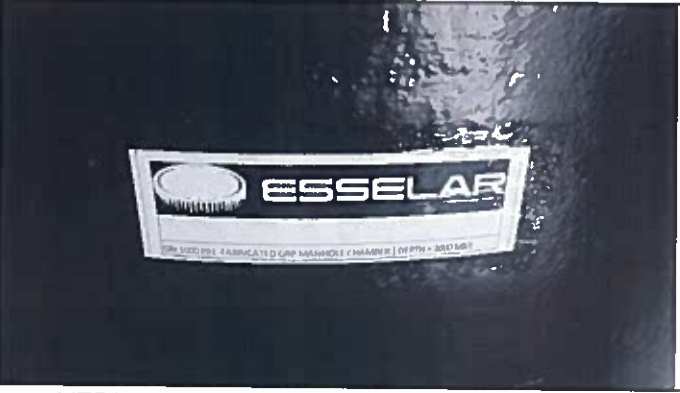
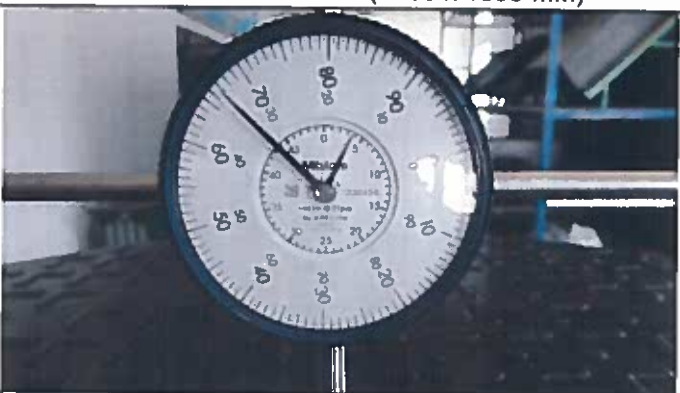
<p>VERIFIED CHAMBER DIMENSIONS (DN-1000 mm)</p>	<p>VERIFIED DEFLECTION INITIAL READING</p>

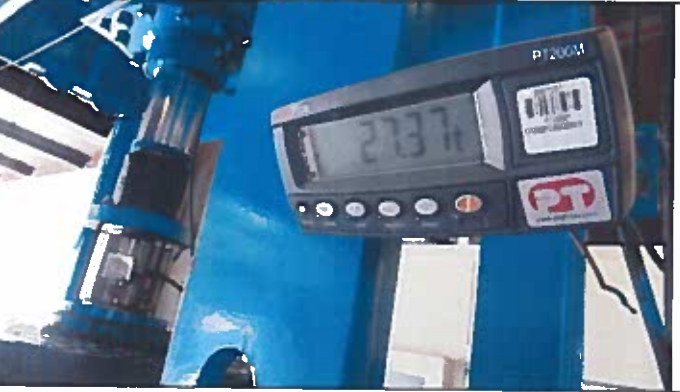
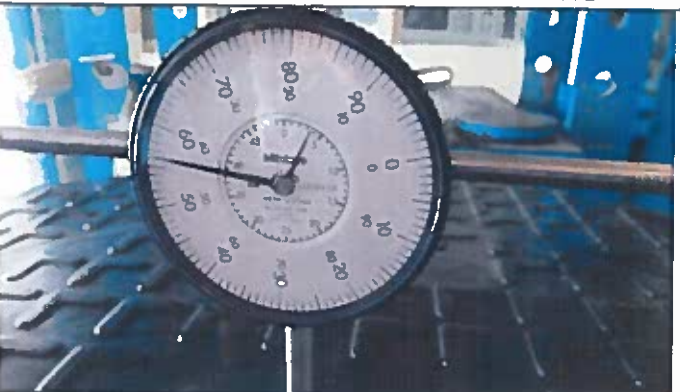
<p>VERIFIED LOAD TEST READING (DN-1000 mm)</p>	<p>VERIFIED DEFLECTION FINAL READING</p>

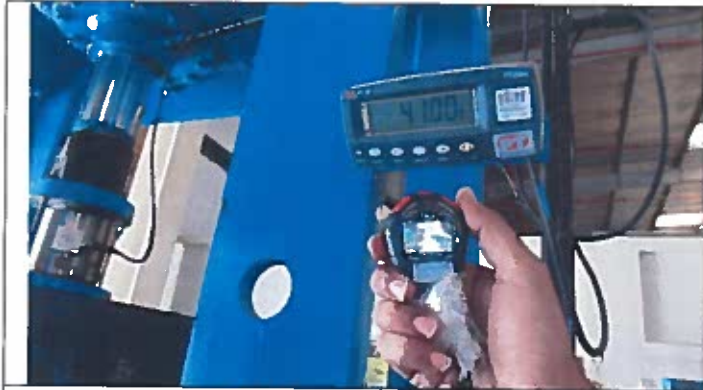
VERIFIED LOAD TEST READING (DN-1000 mm)

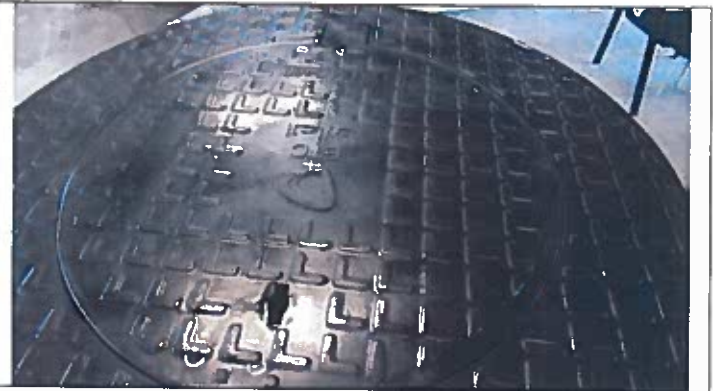
VISUAL INSPECTION (DN-1000 mm)

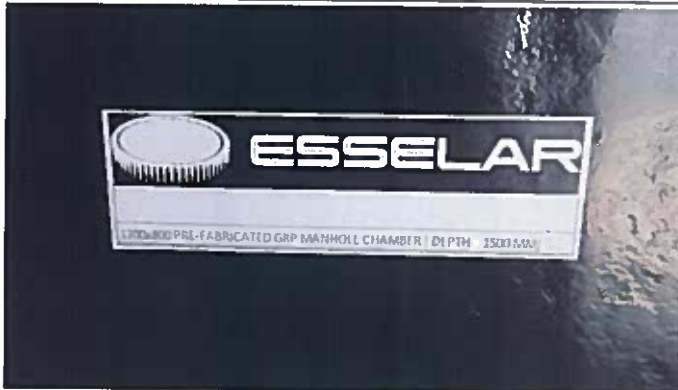
VERIFIED CHAMBER DIMENSIONS (1200 x 800 mm)

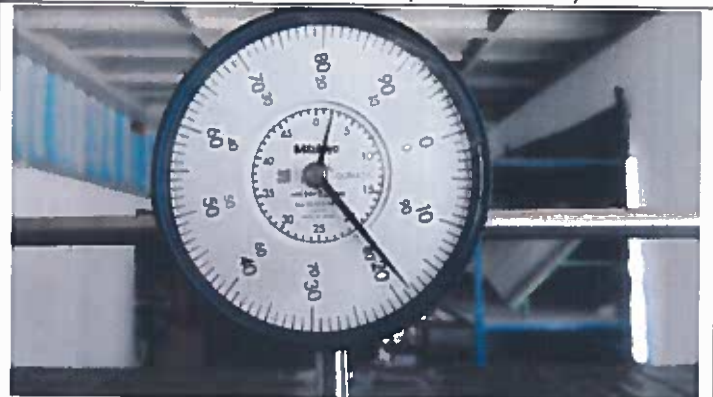
VERIFIED DEFLECTION INITIAL READING

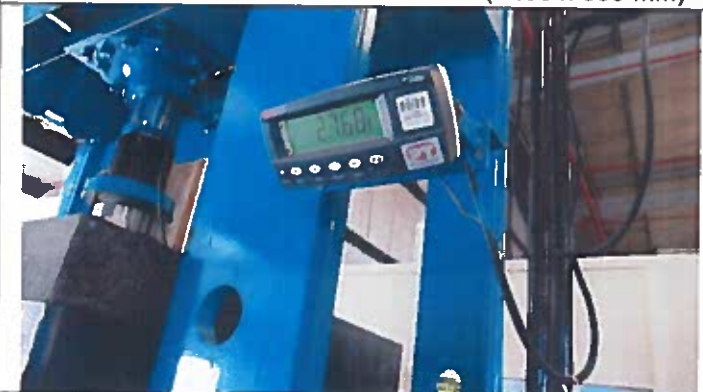
VERIFIED LOAD TEST READING (1200x800 mm)

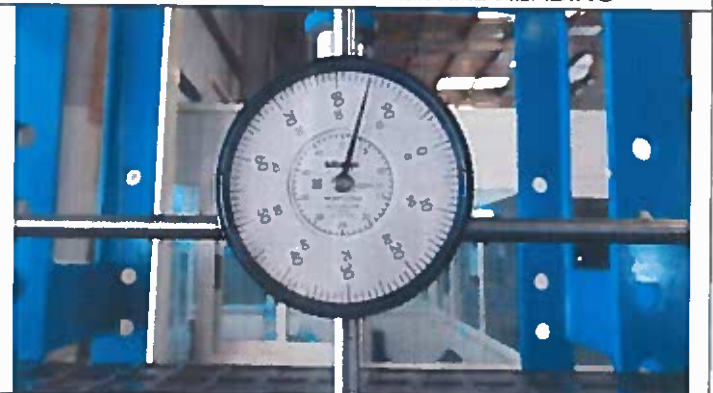
VERIFIED DEFLECTION FINAL READING

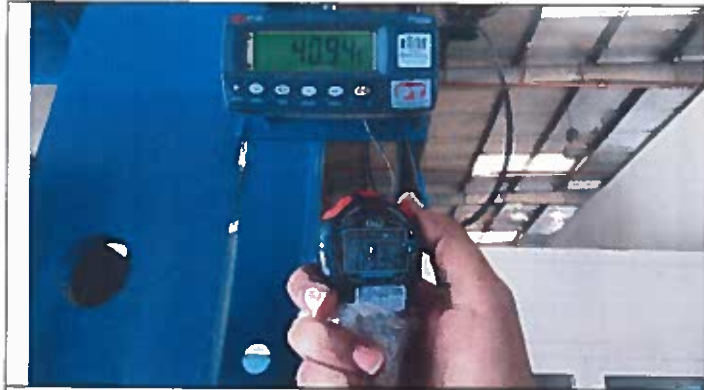
VERIFIED LOAD TEST READING (1200 x 800 mm)

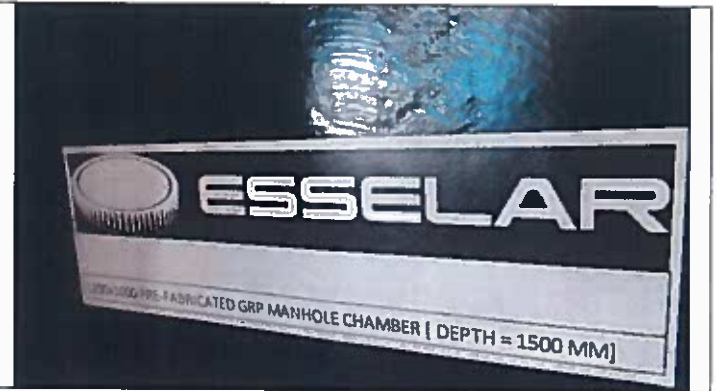
VERIFIED CHAMBER DIMENSIONS (1200 x 1000 mm)

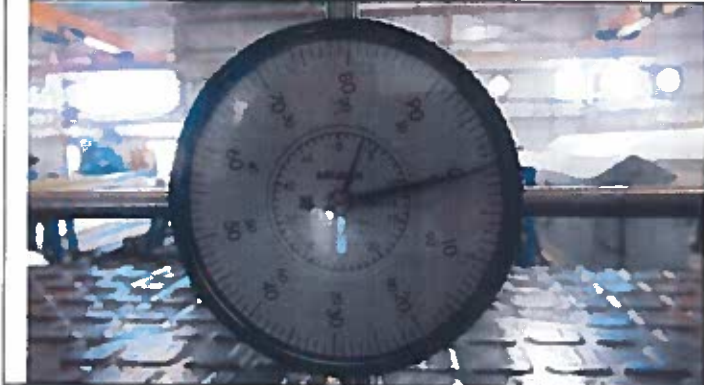
VERIFIED DEFLECTION INITIAL READING

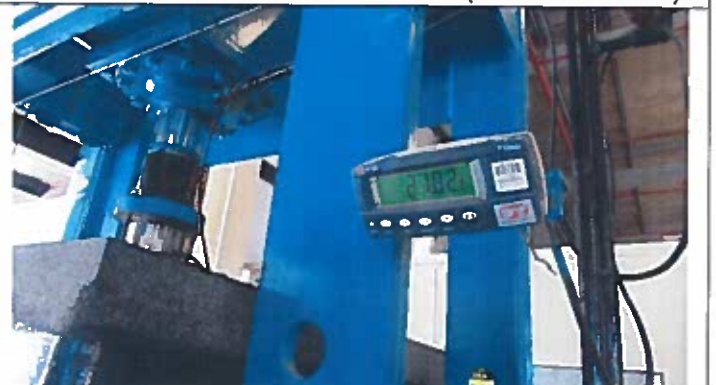
VERIFIED LOAD TEST READING (1200 x 1000 mm)

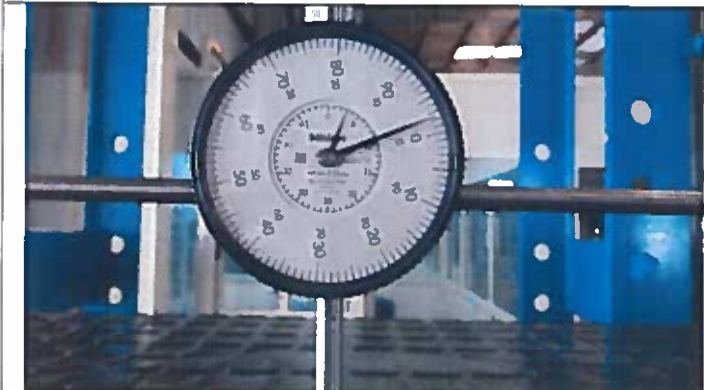
VERIFIED DEFLECTION FINAL READING

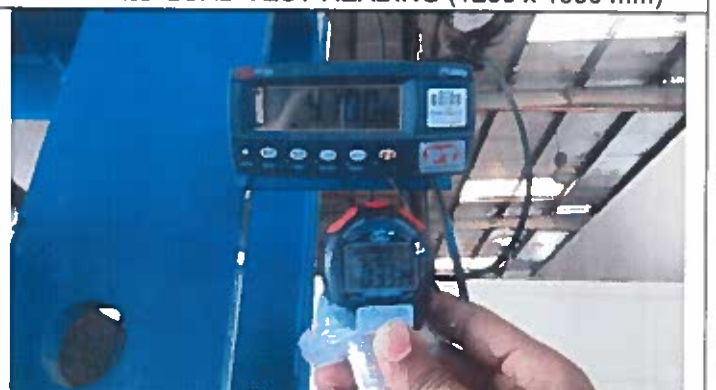
VERIFIED LOAD TEST READING (1200 x 1000 mm)

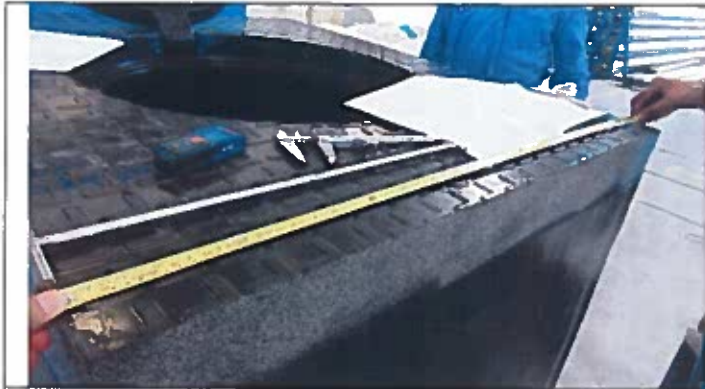
DIMENSIONAL CHECK (1050 mm)

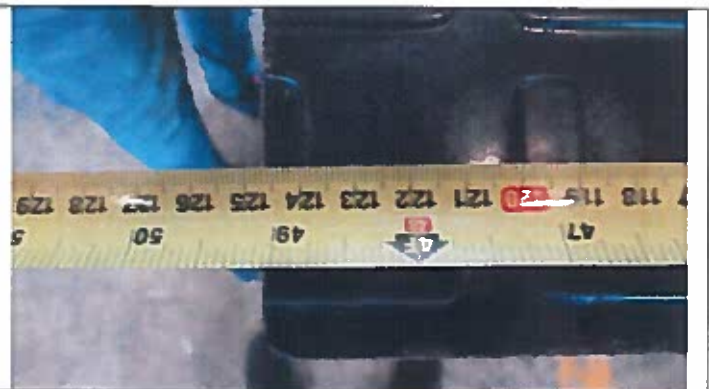
DIMENSIONAL CHECK (1250 mm)

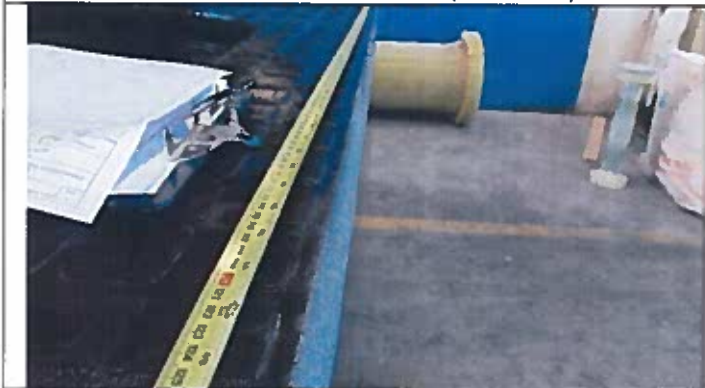
DIMENSIONAL CHECK (1250 mm)

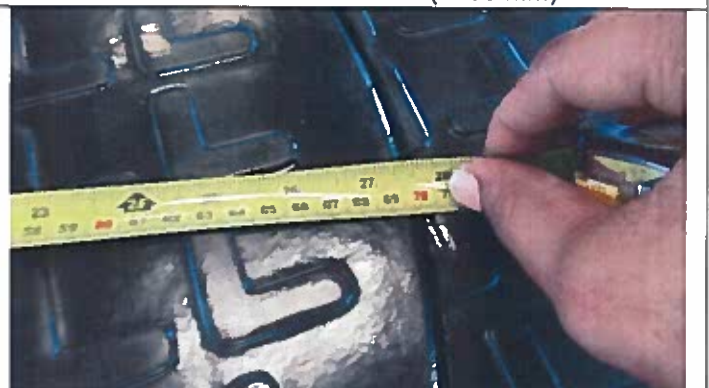
DIMENSIONAL CHECK COVER DIA (700 mm)

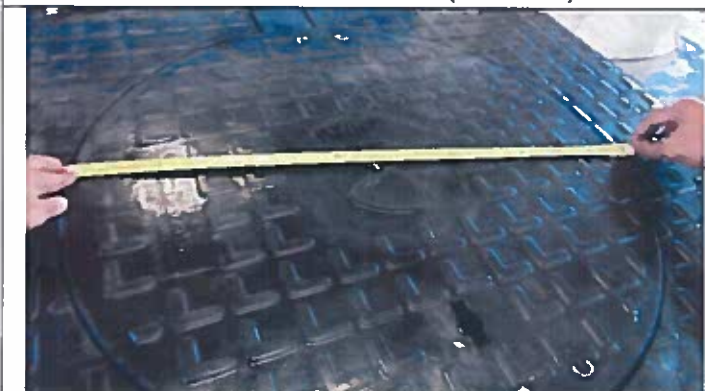
DIMENSIONAL CHECK COVER

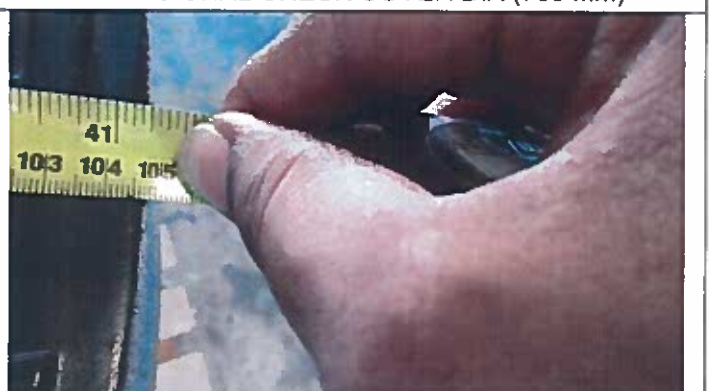
DIMENSIONAL CHECK (1050 mm)

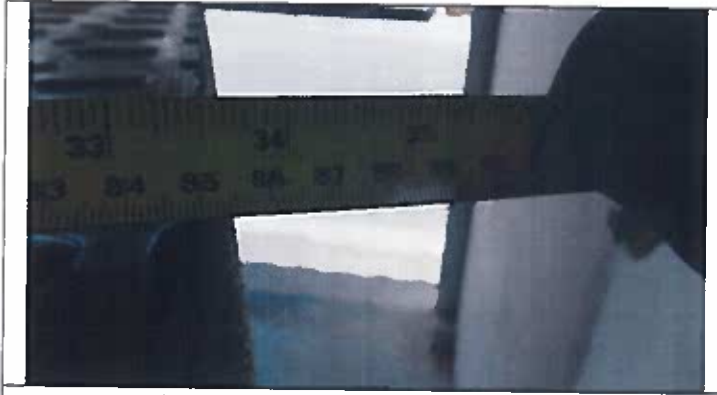
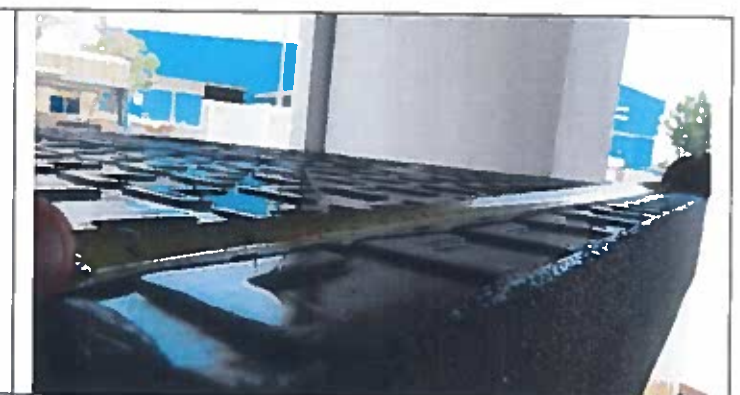
<p>DIMENSIONAL CHECK (850 mm)</p>	<p>DIMENSIONAL CHECK</p>

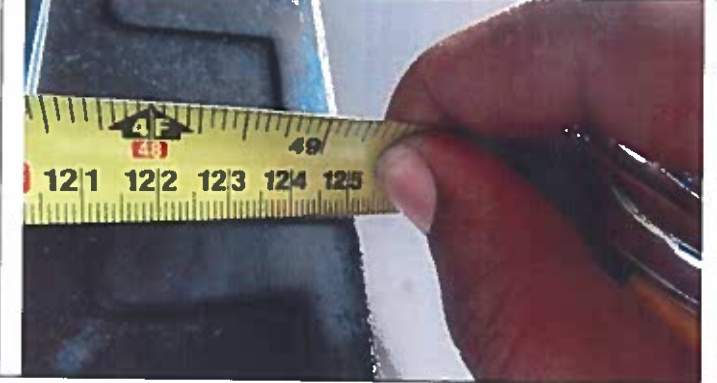
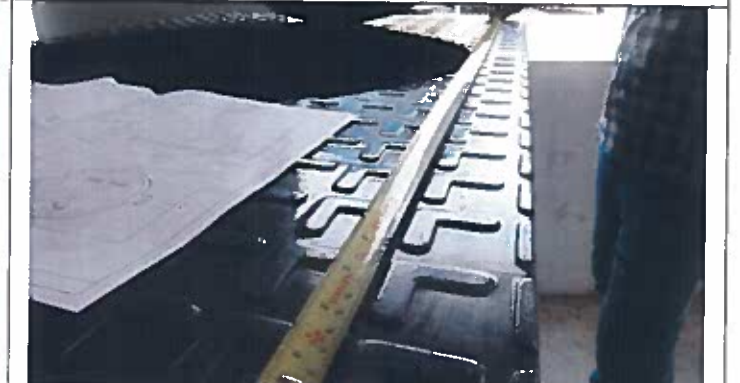
<p>DIMENSIONAL CHECK (1250 mm)</p>	<p>DIMENSIONAL CHECK (1250 mm)</p>

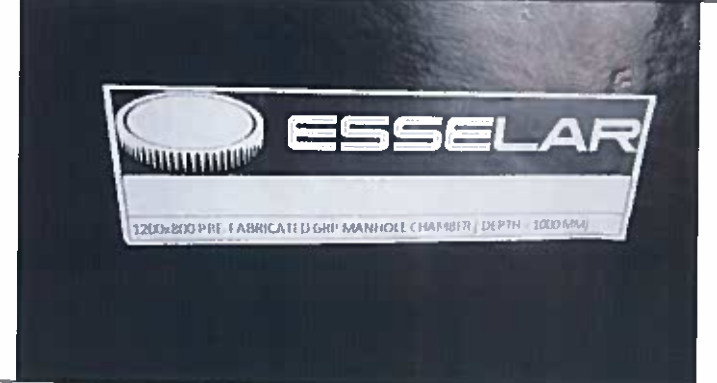
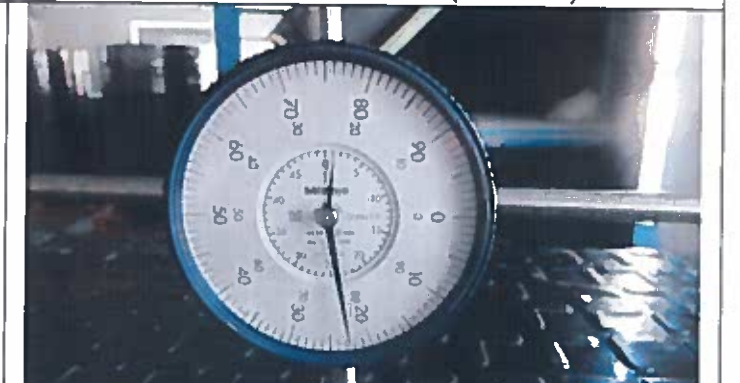
<p>VERIFIED CHAMBER DIMENSIONS (1200 x 800 mm)</p>	<p>VERIFIED DEFLECTION INITIAL READING</p>

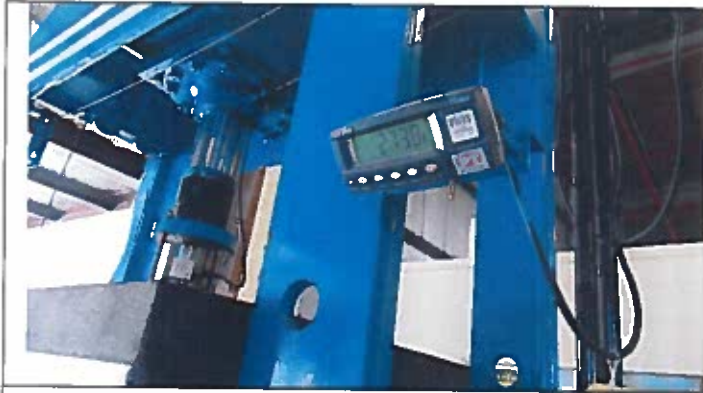
VERIFIED LOAD TEST READING (1200 x 800 mm)

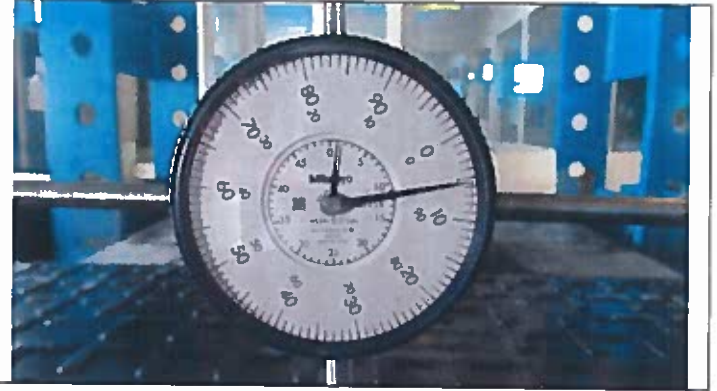
VERIFIED DEFLECTION FINAL READING

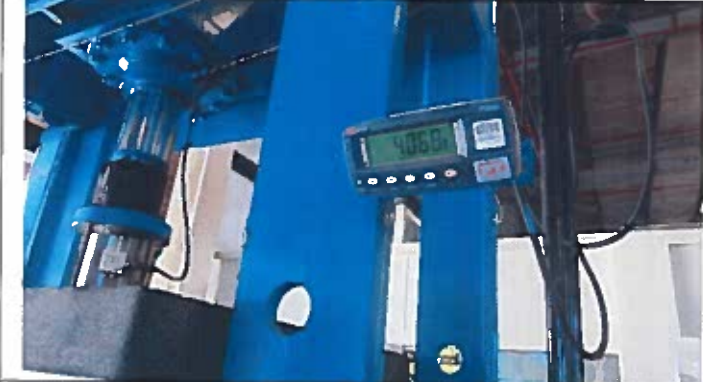
VERIFIED LOAD TEST READING (1200 x 800 mm)

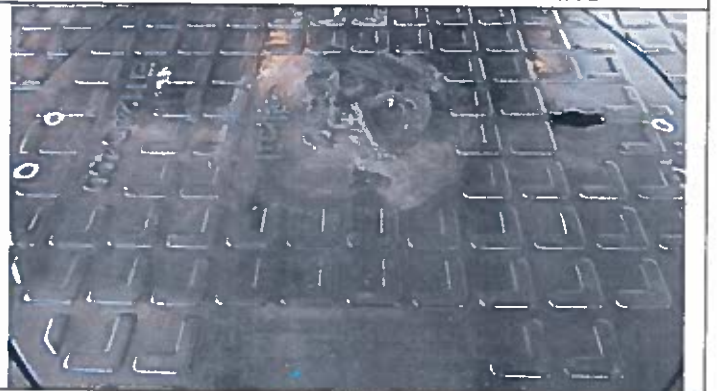
VISUAL INSPECTION (1200 x 800 mm)

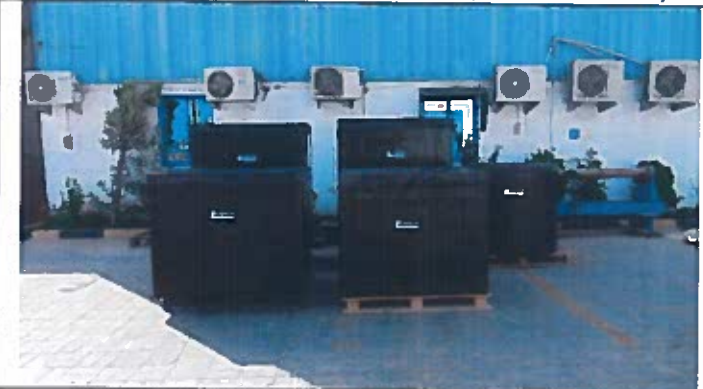
OVERALL OFFERED MANHOLE CHAMBERS
(QTY-05 no's)

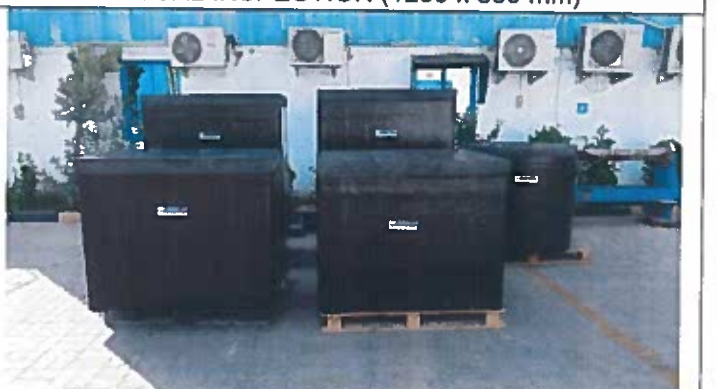
OVERALL OFFERED MANHOLE CHAMBERS
(QTY-05 no's)
